REGROWTH
KURRI KURRI

Project	Hydro Kurri Kurri site redevelopment project	From	Alysia Norris
Subject	Community Consultative Committee Meeting	Tel	1800 066 243
Venue/Date/Time	Thursday 21 June 2018 Hydro Aluminium 6.01pm – 6.47pm	Job No	2218982
Copies to	All committee members		
Attendees	<p>Mr Andrew Walker – Hydro Kurri Kurri Project Manager (AW)</p> <p>Mr Richard Brown – Managing Director, Hydro Kurri Kurri (RB)</p> <p>Mrs Kerry Hallett – Hunter BEC (KH)</p> <p>Mr Kerry McNaughton – Environmental Officer, Hydro Kurri Kurri (KM)</p> <p>Clr Darrin Gray – Cessnock City Council (DG)</p> <p>Mr Ian Shillington – Cessnock City Council (attending in place of Martin Johnson and Gareth Curtis)</p> <p>Mr Michael Ulph – CRG Chair, GHD (MU)</p> <p>Mr Rod Doherty – Kurri Kurri Business Chamber (RD)</p> <p>Clr Robert Aitchison – Maitland City Council (RA)</p> <p>Mr Allan Gray – Community representative - Retired Mineworkers (AG)</p> <p>Mr Bill Metcalfe – Community representative (BM)</p> <p>Mr Brad Wood – Community representative (BW)</p> <p>Alysia Norris – GHD (Minutes)</p>

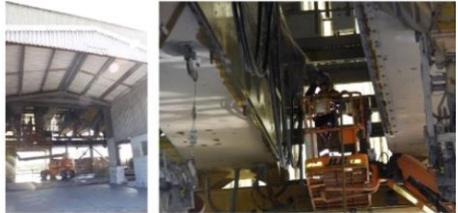
Line 2 PTA Crane wash down – April 2018

Last meeting we talked about cleaning the cranes down, so this is just some photos showing how we are doing it, using an EWP (elevated work platform) to guide up the fire hose, spraying the top of the girders of the cranes to remove any dust or alumina.

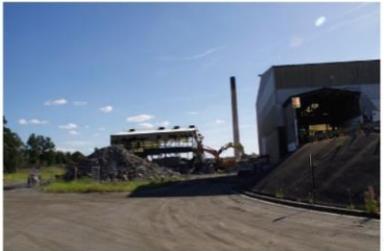
Line 2 South – demolition of last few bays in April 2018

This photo was taken in April showing the last half a dozen bays being demolished, at the south end of Line 2.

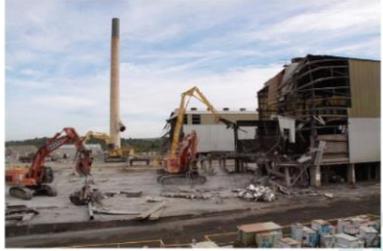
Demolition to column 56 at northern end of Line 2 in May 2018

This is the north end of Line 2 in May and they've finished at this stage, just demolished column 56, and we're planning to do a final separation of column 51-52 area. For the last two months, CMA has mainly been focusing on sorting scrap, pulverising concrete and backfilling voids in this area south of Pot Line 2 and 3, just tidying up the site.

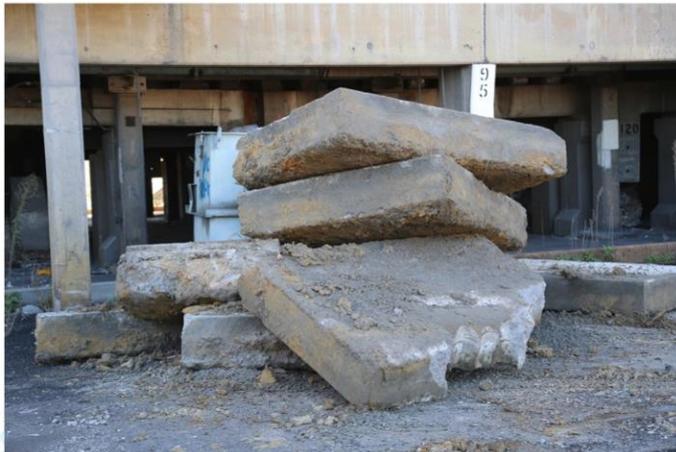
Concrete plinths removed from underneath transformers at 3BS substation. Anything with oil staining will be checked for PCB contamination

They've also been doing substation work, so removing transformers, removing the concrete plinths under the

transformers, and then digging out the soil. They've been focusing on areas where there's visible oil stains and Ramboll has been assisting by taking samples of those oil-stained soils and we're checking them for PCBs because some of the transformers did contain PCBs.

This particular one, 3B south didn't have any PCBs in it but it had some hydrocarbons, non-PCB transformer oil had leaked into the ground. So, once we dig down we take samples of that material, and it's analysed. If it comes back as a pass, that's OK - we've gone deep enough. If it's a fail, it's still too high in hydrocarbon or PCBs, we have to dig down further, usually in about 100mm increments. This particular one was fine, it passed, but some other substations we've had to go back two and three times to keep digging out enough material until we're down below the criteria which is seven PPM (parts per million) for PCBs. How much is it for hydrocarbons?

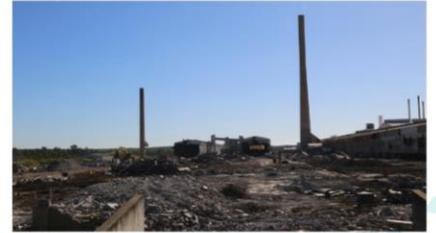
May 2018 - CMA have spent most of May & June cleaning and sorting in L2/3S area

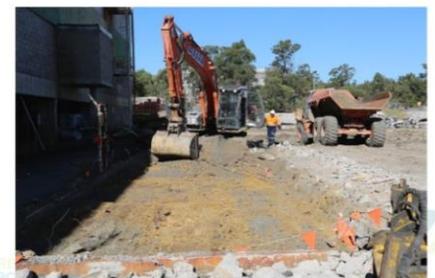
Removal of contaminated/oil stained soils from 3BS substation. Anything with oil staining is checked for PCB's.

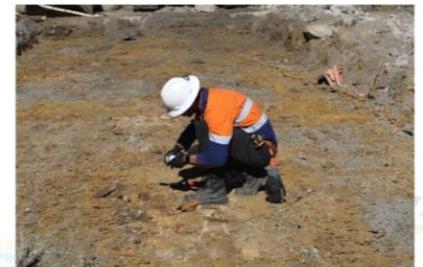
Validation sampling at 3BS substation by Ramboll in May 2018

This is a photo of Craig from Ramboll taking samples. We've also been backfilling voids. That concrete that we're crushing, CMA are passing an electromagnet over it and removing the reinforcing steel which you can see there.

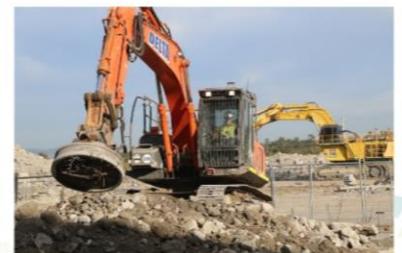
Removal of reo from crushed concrete by electromagnet - May 2018. Concrete to be used for backfill material.

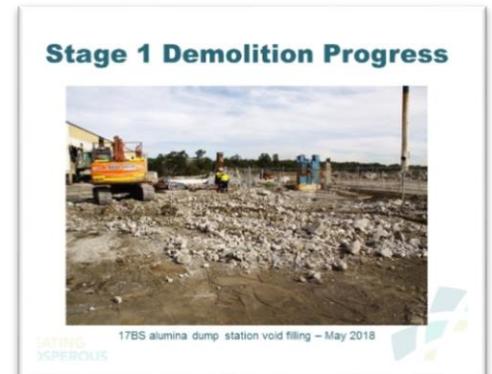
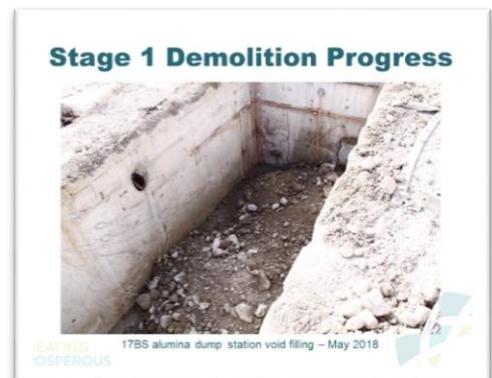
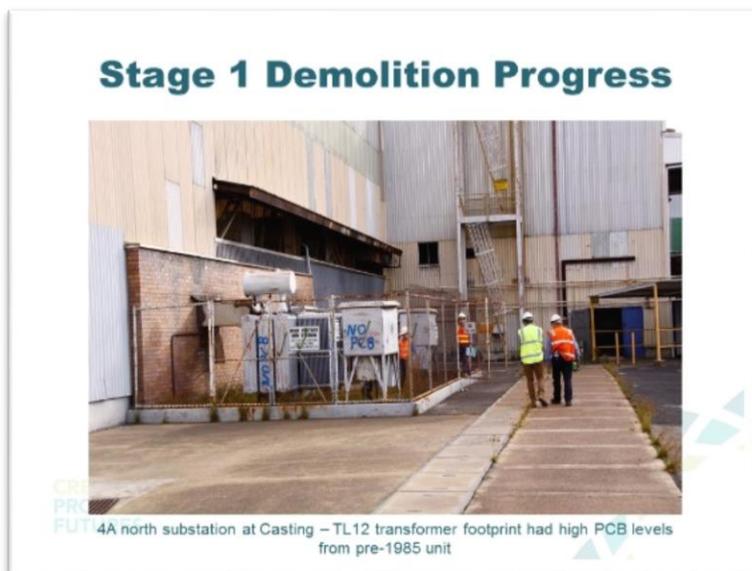
And this is a dump station at the south end of Line 2, 17B south. This is just a few photos of that being backfilled with a combination of crushed concrete and soils from the clay borrow pit that had been previously sampled as being clear for reuse on site for filling voids. By combining concrete with soil we get better compaction.

This particular substation was at the north side of Casting, this was an interesting one. Although the two transformers up here were from the last set of oil analysis results were PCB-free, one of our electrical engineers who has a lot of experience onsite, he alerted us of the fact that transformer TL12, the footprint of that transformer he said will be high in PCBs because the first twelve transformers on site were replaced in about 1985. When we did remove the transformer and checked underneath it we did find high levels of PCBs and we had to go back two and three times to get all the soil out. So that's just an example of someone in our team who has good site knowledge, because you can't just go off the last set of results. We would have picked it up anyway but it was good that he is in the team and is aware of these things.

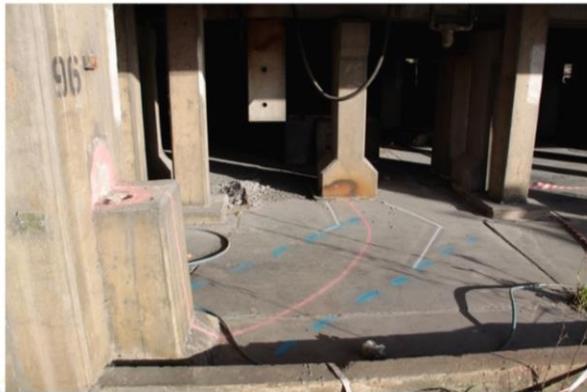
Location and mark out of asbestos conduits in Potline 1

CMA has been using a service locator to pinpoint where they are, which is that red line, and then they marked out the floor for the concrete cutting crew, and they've been saw cutting. So every pot - there's 120 pots in Line 1 - every pot has one of these conduits, so we had to saw-cut all the slabs. This one's after the saw cutting. We also had expansion joints every six bays in the building, so here we've cut in the side of the expansion joint up to this column. There's another cut that you can't see but they'll have to jackhammer around there because there's asbestos around that column.

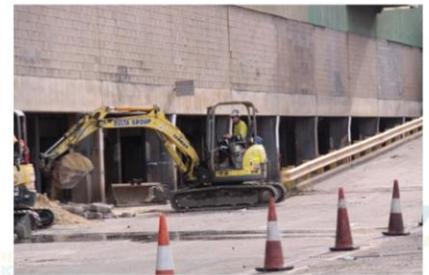
Machine digging of trenches above conduits in Line 1

This photo here: they're using a little excavator with a hammer and they're just hammering up the concrete, just this bit. They haven't done these ones yet because they're a bit more tricky. And removing that concrete, and then removing the soil down to about 100mm above the conduit, and then they hand-dig hand down to the conduit and around it. They don't use the machine because they don't want to break the conduit.

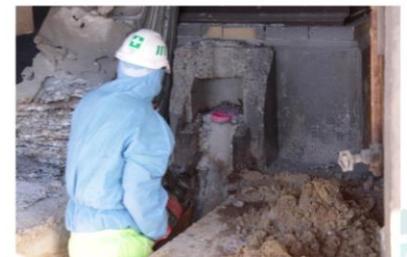
Jack hammering of concrete either side of asbestos conduit by ACM removal crew

They were used for thermocouples and put into the voltage signal for each pot, back to the pot room process-controlled computer system. The conduit ran from here out to the building column into a plinth. Here they're wrapping – sorry in this photo he's using a little kanga hammer and jackhammer on the concrete either side,

being careful not to break the conduit which is painted in pink paint.

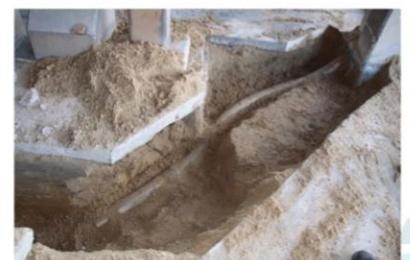
Asbestos conduit in Line 1 following machine and hand digging

AW: Oh yeah. So this is one of those asbestos conduits. They're still in reasonably good condition but they're in sections and they're joined with what appears to be bitumen. Most of it is coming out OK but sometimes they do break at the joints. The conduit actually comes up in this foundation for the pot column.

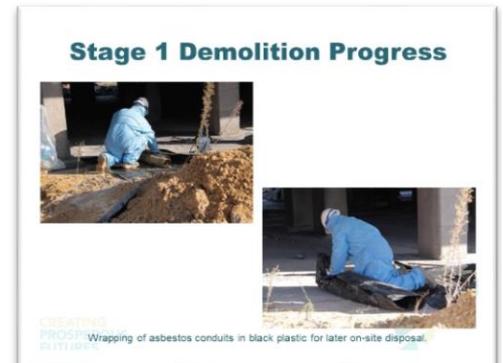
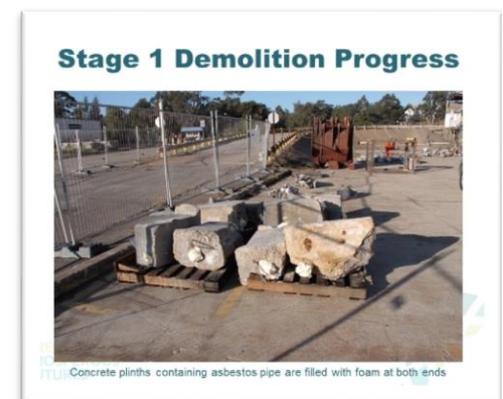
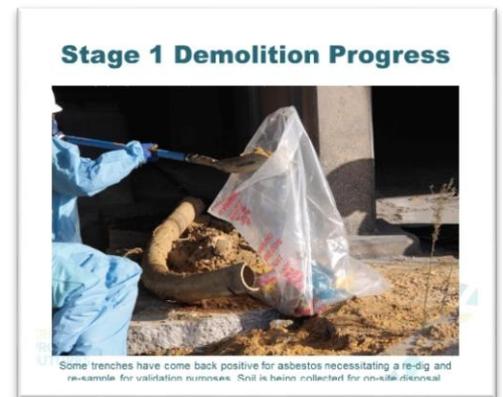
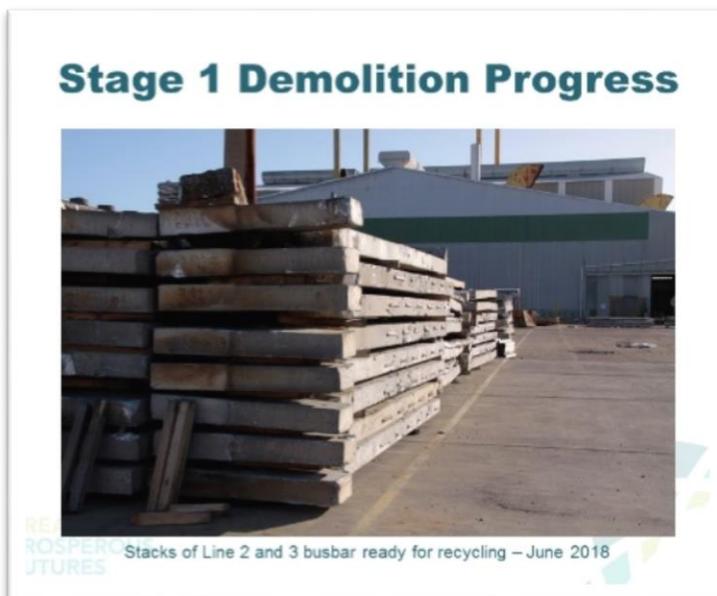
Here the guys are just wrapping the conduit in plastic and they will be stored down in the carbon plant and eventually they will go into the new containment cell.

These are the plinths at the other end of the conduit. They still have the asbestos pipe inside them but we filled each end with foam so there was no chance of any fibres escaping. And they're getting being put on pallets and they're also being stored down in the carbon plant and they will also go into the cell. It's not worth trying to recover the concrete. It's better to put them into the cell.

We have had a couple of failures, so we've gone through after removing the conduit. Ramboll take a soil sample – I think we've had four of five fails - so, then CMA have to go back and hand dig another 100mm below the level that they've previously reached and that soil's been sorted into these bags and also taken to the carbon plant and then Ramboll take another set of samples and then hopefully that will come back negative for asbestos.

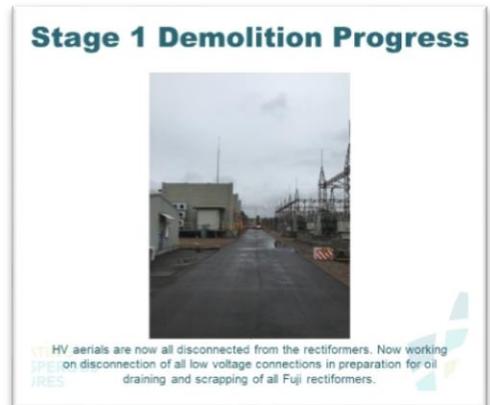
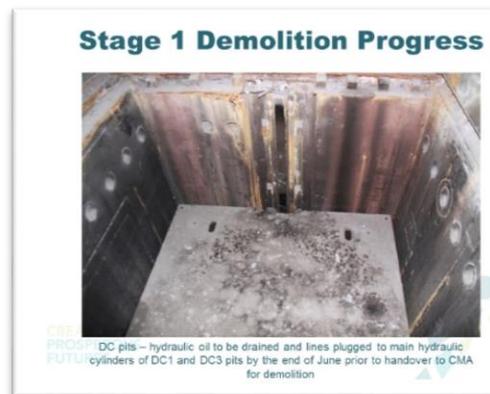
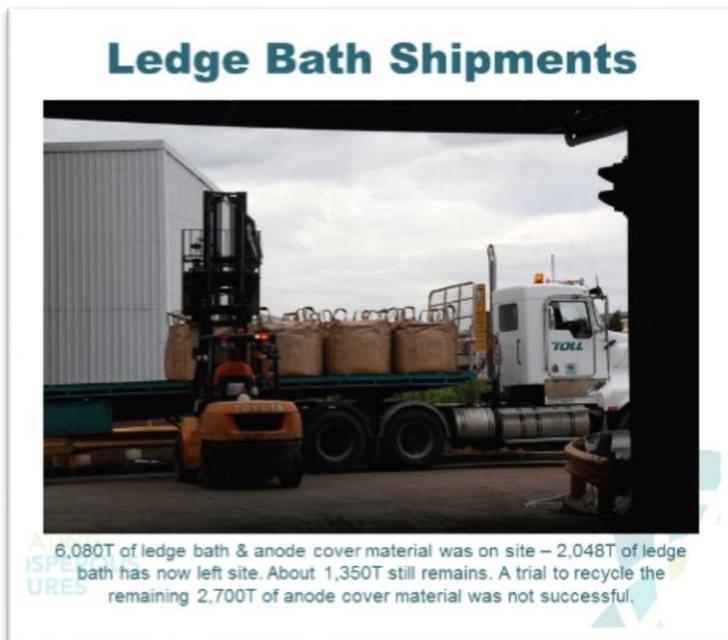
In the cast house, we've had some delays with getting the contractors in but next week they're about to drain all the hydraulic oil and unbolt all the cylinders and the rams under the DC pits and one other pit which is a spacer storage rig.

AW: That cleaning of the DC pits that you saw there, that was something that we used to do routinely, every four weeks. But DC1, for some reason, they didn't do it. There were bits of aluminium that used to sometimes leak out of the in-box at the start of the cast and they would collect at the bottom of the pit. So they'd just get vacuumed out with a king vac vacuum truck. We had to do that first to make it safe to access the facilities.

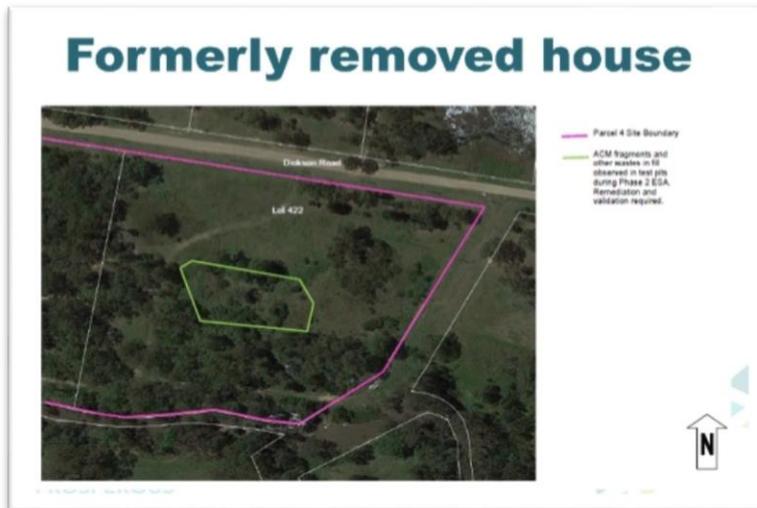
This is just another example. That's a house. This is Horton Rd and the Expressway, with some asbestos fragments on the surface of the property, probably just from old sheds and things or rubbish disposal that's occurred on the property in the past.

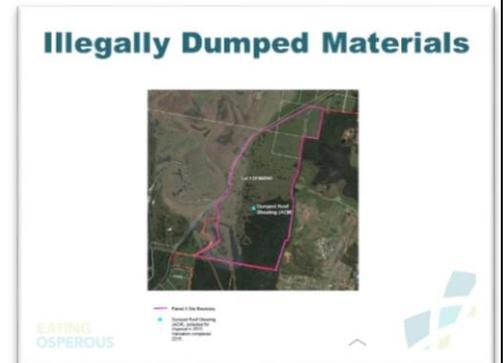
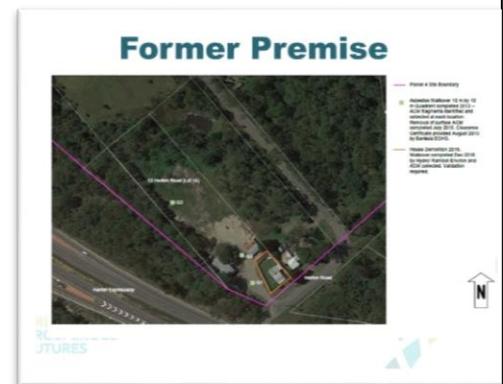
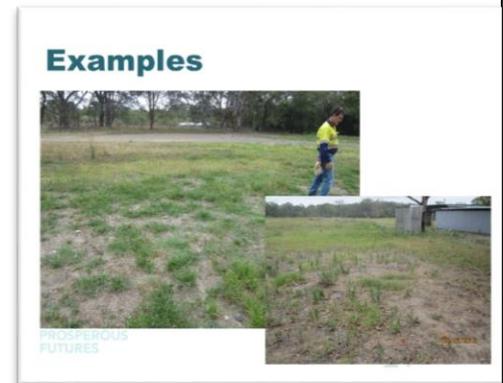
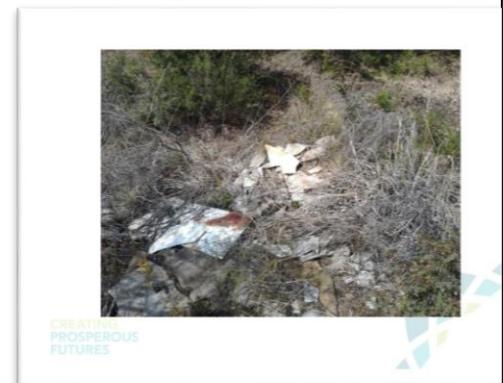
And this one is an example of where there was a house there that was demolished and we've got some asbestos including a bit of buried waste there that we've found when doing some test pits. That's just a couple of examples of what we're looking at, and here's some fragments of asbestos on the surface. Some of the remediation is just to go and pick this up and do a bit of a walkover and a dig under the surface and just confirm we've removed it all. Other parts have got some buried asbestos where we can see some fill's been placed and has asbestos in it and we'll actually remove that as part of the remediation works.

That's an example of illegal dumping and it's been removed from somewhere offsite and disposed on the property. Sometimes these are nicely stacked sheets of roof sheeting, corrugated roof sheeting, which is good. Sometimes it's been broken up and out in the bush so we'll go in, pick this up and validate the soil that

remains is free of asbestos and then we write that up basically as a validation report and that's the end.

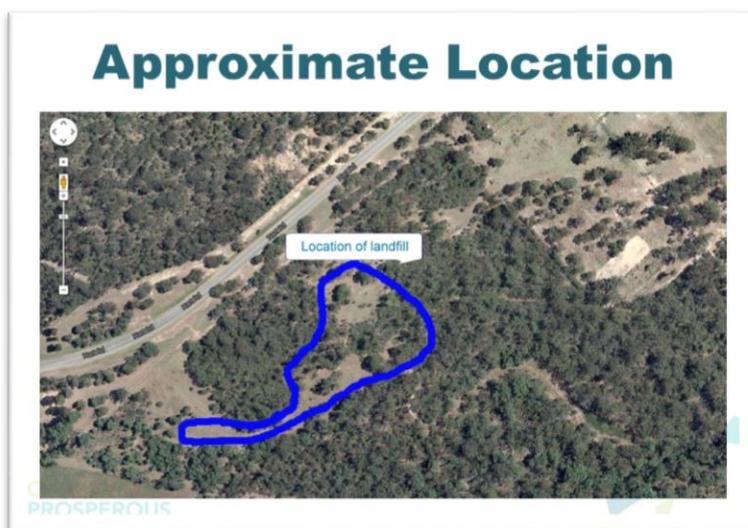
FR: And the Expressway's up here. So, there's an area there where the landfill was operated in the 40s, 50s, 60s and was kept on fire, by the look of it, throughout that period, which was not uncommon for landfills at the time. What's left through here is a combination of ash, glass bottles and the occasional metal item, but not much because a lot of metal was not, you know, disposed of at that time, and asbestos because there's materials through there as well, and sand really. So it's a bit of an area that was probably a low lying area and has been infilled so we've got a program to remove that.

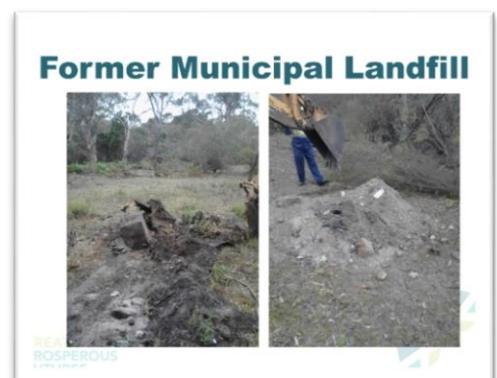
Proposed Remediation

That's a picture there of what it looks like, mostly sand and debris.

The remediation process is to bring the material back to site and we've got an area that's been put aside to temporarily stockpile all of this impacted material and we'll backfill the excavations with natural material that is clean and suitable for the use and then validate the site, write a report – we have our site auditor – he'll review that report and then prepare a statement that the site is suitable for its use under the zoning.

- Return material to site for temporary stockpiling
- Backfill excavations with natural material
- Achieve site auditor sign off that sites are suitable for the intended use
- Place temporarily stockpiled material in containment cell once available.
- Ensure that temporary stockpiled areas are uncontaminated
