Global Industry Standard on Tailings Management (GISTM)
Hydro public disclosure report 2025

This document serves as public disclosure in compliance with Requirement 15.1 of the Global Industry Standard on Tailings Management (GISTM), covering all of Hydro's tailings facilities within the scope of the GISTM.

Alunorte

DRS1 and DRS2

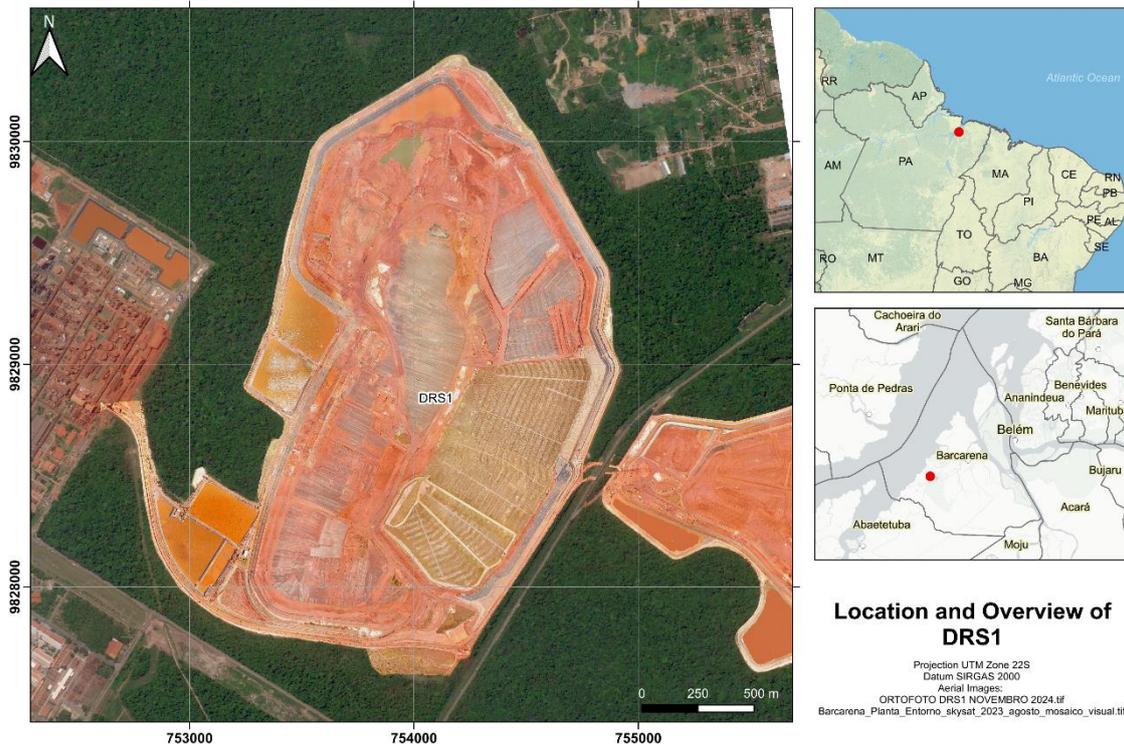
DRS1 Description	
Purpose	Storage of residues generated in alumina production
Current height	45.60 m
Final height	45.60 m
Volume of residue stored ⁵	65Mm ³
Maximum residue storage capacity ⁶	71Mm ³
Implementation stages ⁷	The facility was constructed in 1994 and 1995, and underwent 11 expansions (expansions 1, 2, 3, 4, 5, 6, 7, South cell, East cells CL1, CL2, and CL3).
Current status	In operation, with progressive closure and rehabilitation

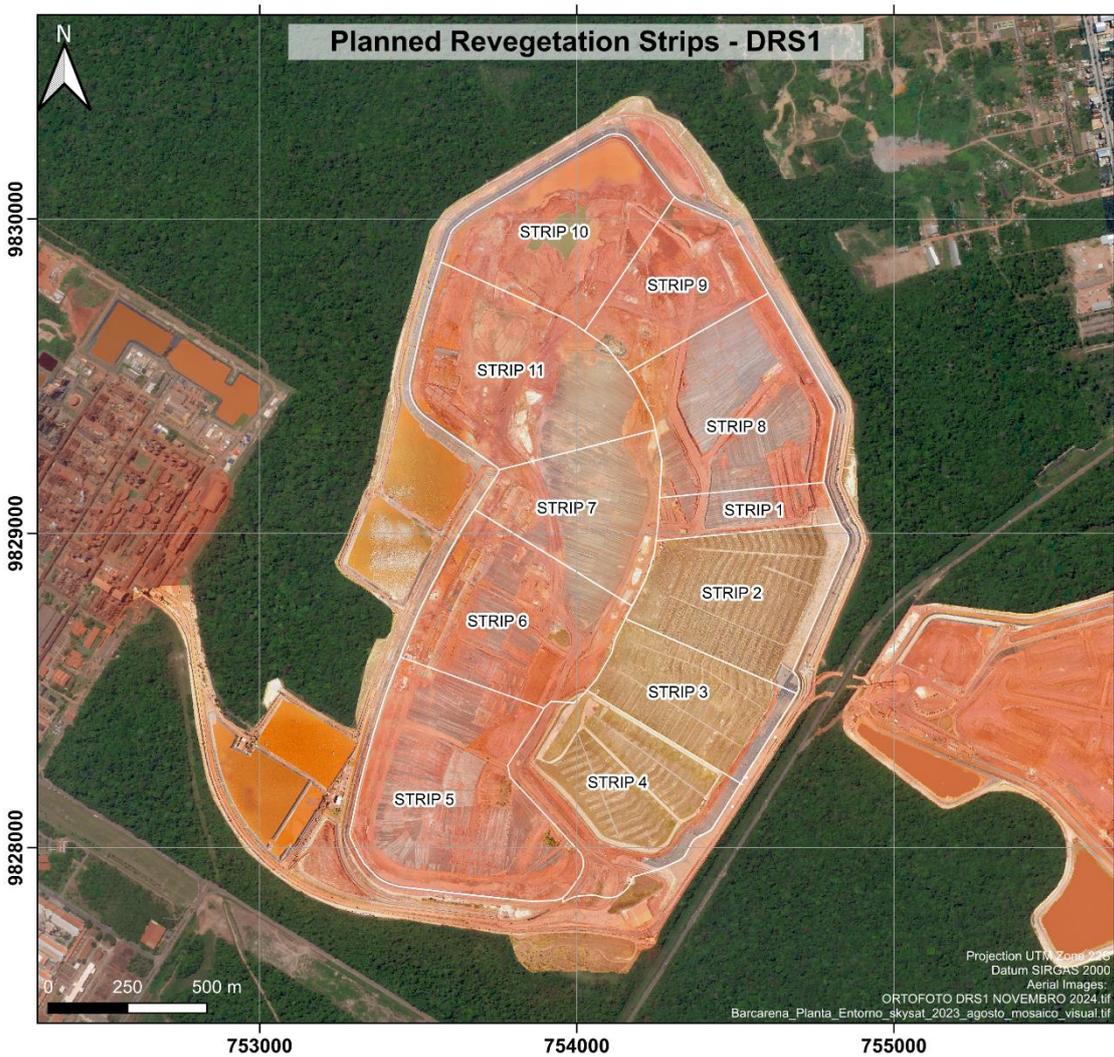
The closure is divided into 11 rehabilitation strips. Strips 2, 3 and 4 have already been rehabilitated, covering approximately 75 ha. The design is based on capping and storing the filtered residue with surface and subsurface water drainage, and cover systems consisting of HDPE geomembrane to lining the stored residue, covered by a densified soil, and revegetation of the surface.

The image below shows the configuration of DRS1 with the proposed revegetation strips.

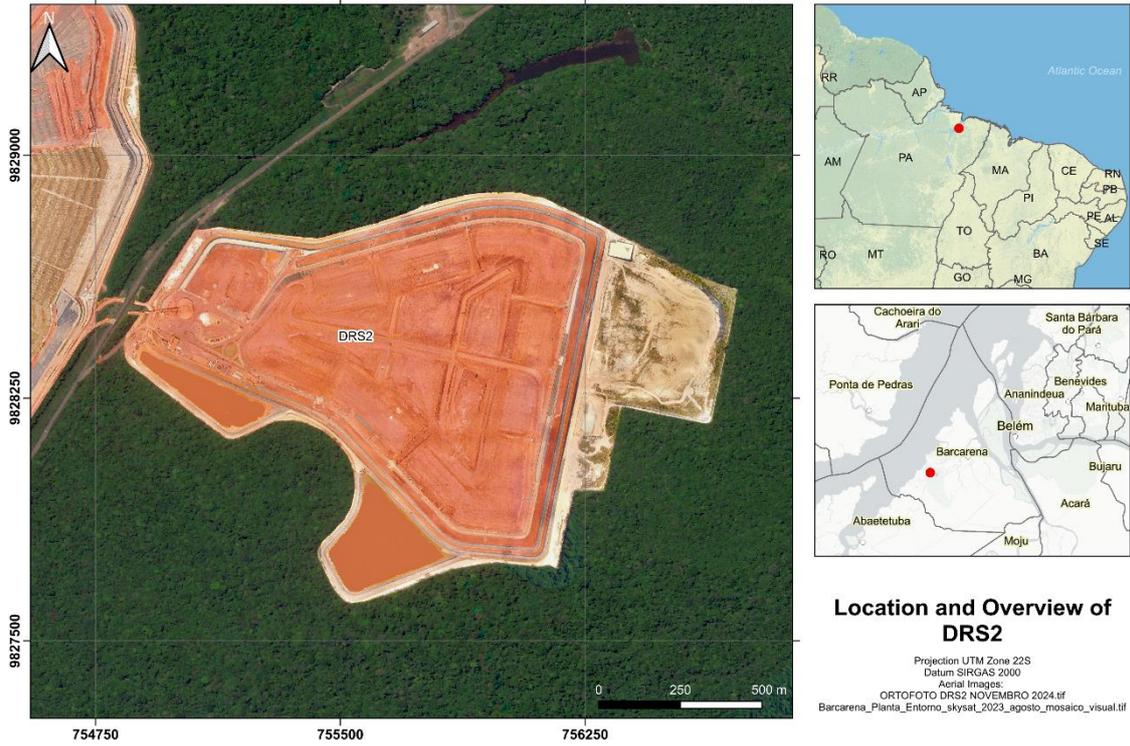
DRS2 Description	
Purpose ⁹	Storage of residues generated in alumina production
Current height ¹⁰	33.40 m
Final height ¹¹	71.00 m
Volume of residue stored ¹²	11 Mm ³
Maximum residue storage capacity	25 Mm ³
Implementation stages ¹³	Single stage construction, 2015.
Current status	In operation
Consequence classification ¹	Very high
Construction type	Initial infrastructure in compacted earth fill embankment. Stack in compacted residue.
Construction type	Compacted earth fill embankment, downstream raised.

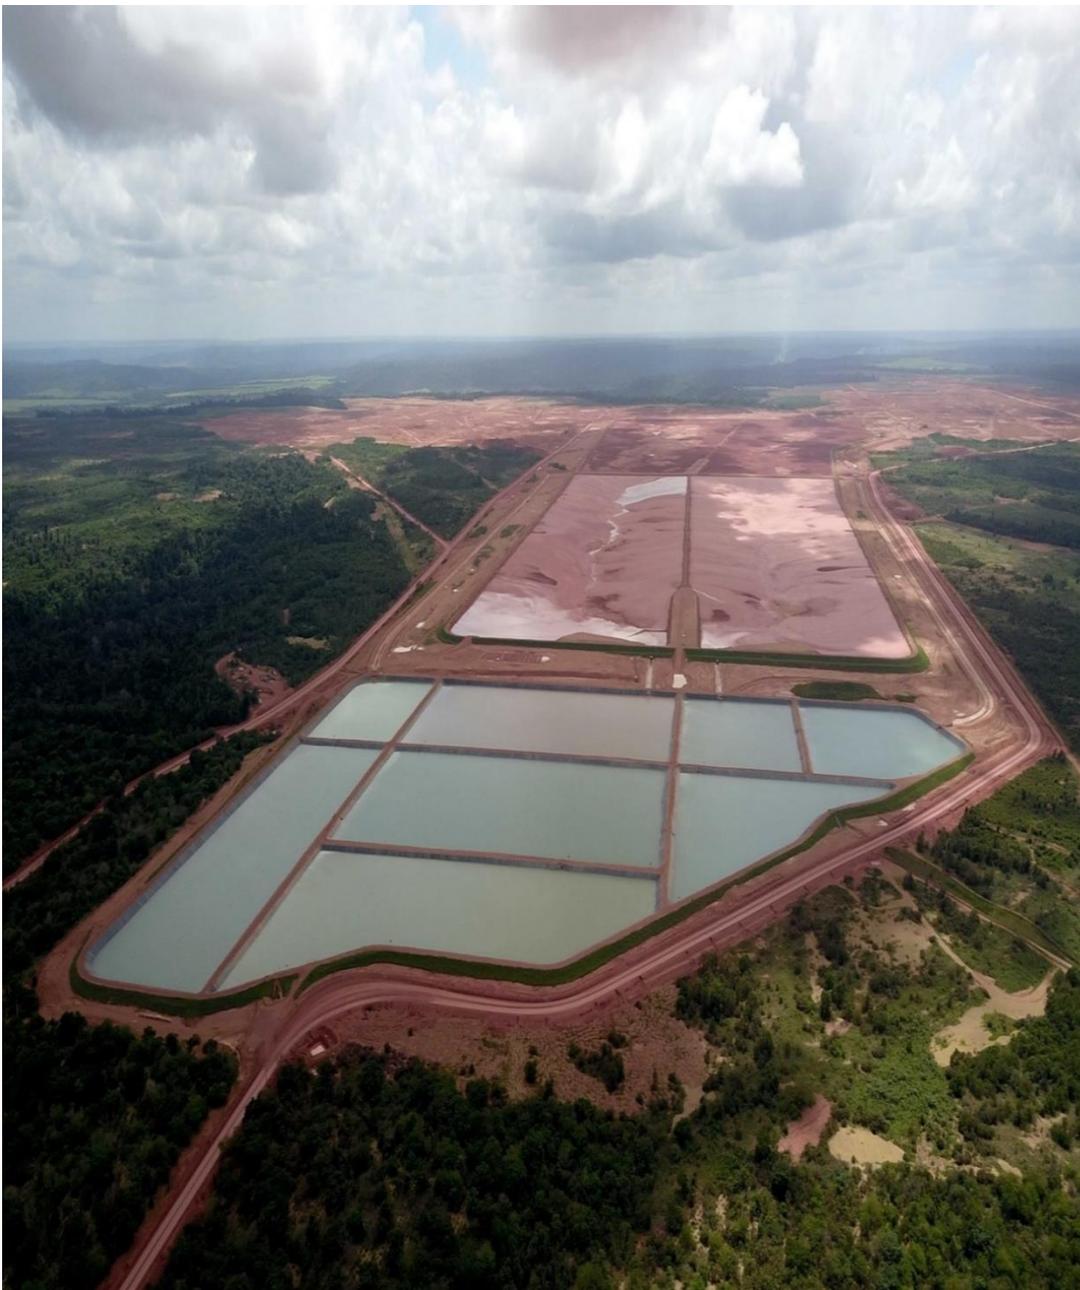
TDA (previously named RP1)

The TDA of Mineração Paragominas S.A. comprises of four disposal quadrants (TDA-A, TDA-B, TDA-C, and TDA-D) delimited by internal and peripheral dikes. The TDA is designed for the temporary drying of tailings generated bauxite during ore beneficiation.

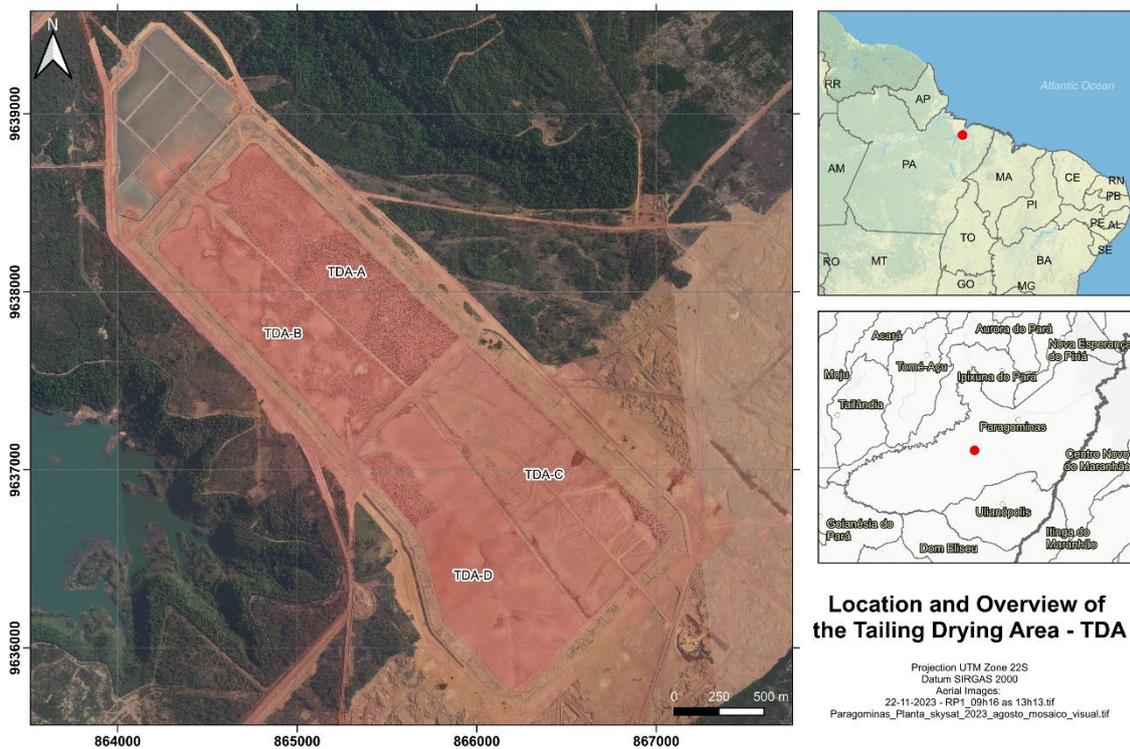
TDA Information	
Purpose ²⁶	Temporary drying of tailings from bauxite ore beneficiation
Current height	13.50 m
Final height	13.50 m
Maximum tailings storage ²⁷ capacity	10.55 Mm ³

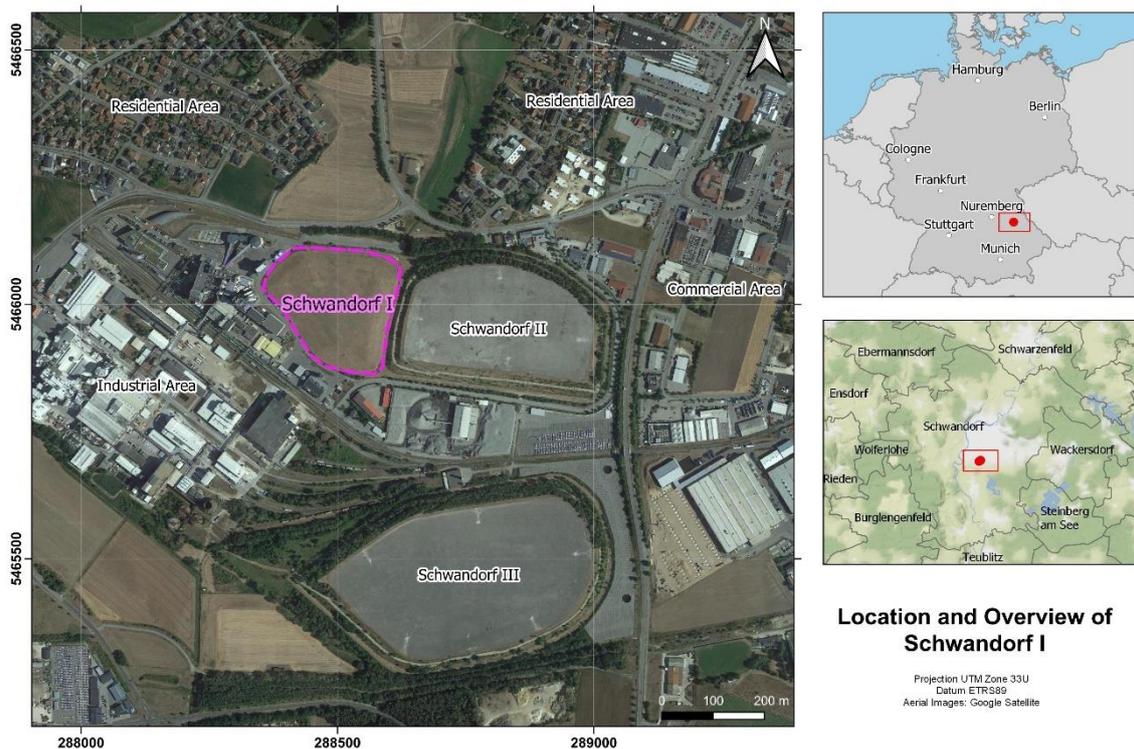
Description of Schwandorf I	
Purpose	Storage of bauxite residue generated from historic alumina production
Current and final height	Approximately 18 m
Volume of residue stored	600,000 m ³
Implementation stages	<p>Constructed and operated between 1936 and 1957. Comprehensive closure measures completed in 1991. In 2009, the authorities issued a closure notice for the TF, formally designating it as closed and in the aftercare phase.</p> <p>Regular monitoring is conducted and reported to the authorities annually, or more frequently as required, in compliance with applicable regulatory permit conditions.</p>
Current status	Post-closure / Aftercare since 2009
Consequence classification ⁴²	High
Construction type	Dome-shaped landform from reconstructed, stacked tailings material

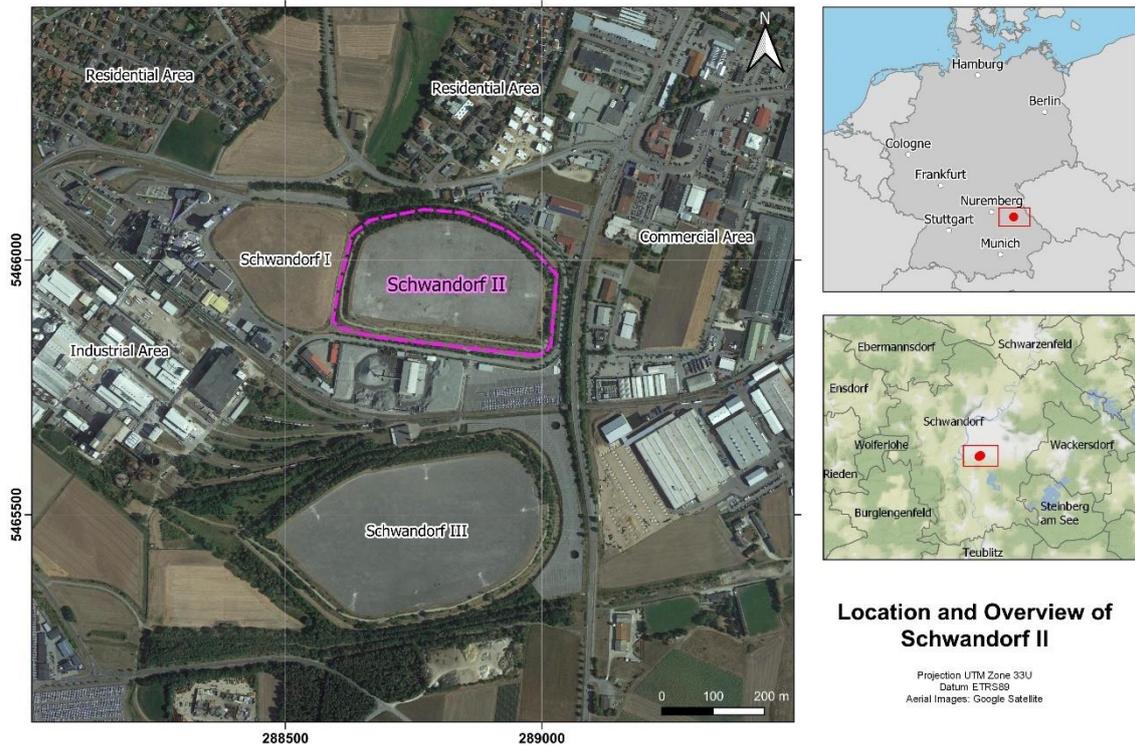
Description of Schwandorf II

Purpose	Storage of bauxite residue generated from historic alumina production
Current and final height	Approximately 12 m
Volume of residue stored	1, 520,000 m ³
Implementation stages	<p>Constructed and operated between 1952 and 1994.</p> <p>Comprehensive closure measures completed in 2009.</p> <p>In 2009, the authorities issued a closure notice for the TF, formally designating it as closed and in the aftercare phase.</p> <p>Regular monitoring is conducted and reported to the authorities annually, or more frequently as required, in compliance with applicable regulatory permit conditions.</p>
Current status	Post-closure / Aftercare since 2009
Consequence classification ⁴³	High
Construction type	Hybrid of mechanical and slurry deposition. Upstream raised dams

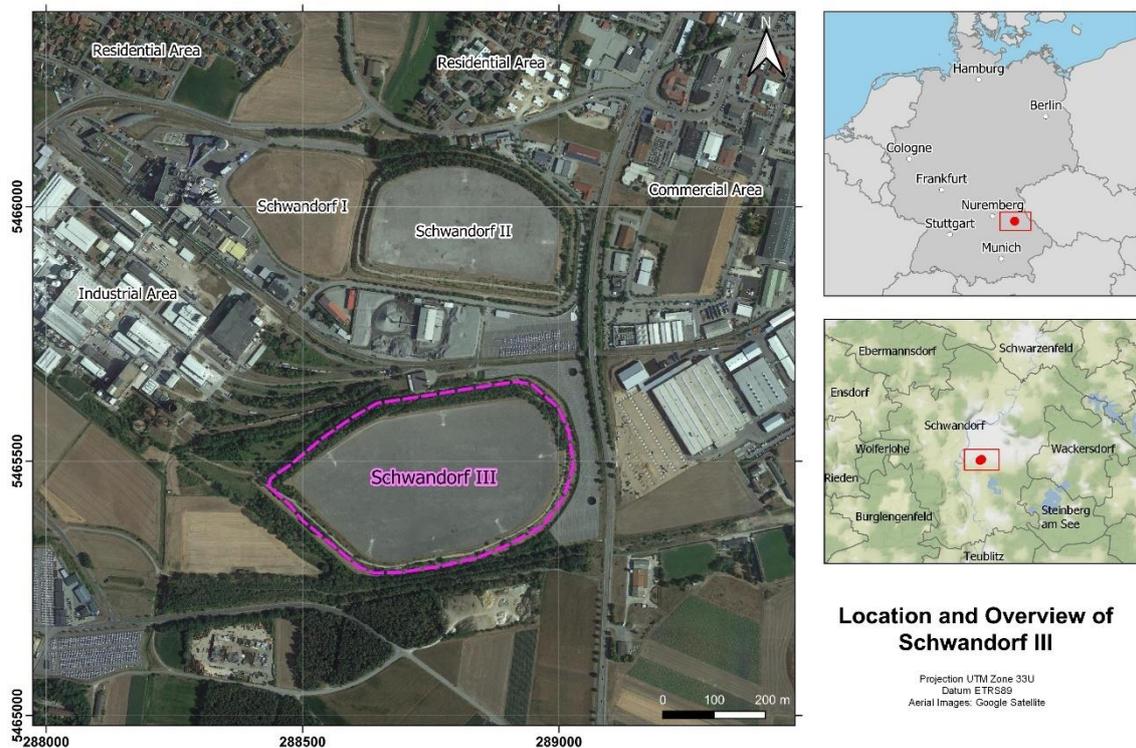
Description of Schwandorf III	
Purpose	Storage of bauxite residue generated from historic alumina production
Current and final height	Approximately 12 m
Volume of residue stored	1,510,000 m ³
Implementation stages	<p>Constructed and operated between 1952 and 1994.</p> <p>Comprehensive closure measures completed in 2009.</p> <p>In 2009, the authorities issued a closure notice for the TF, formally designating it as closed and in the aftercare phase.</p> <p>Regular monitoring is conducted and reported to the authorities annually, or more frequently as required, in compliance with applicable regulatory permit conditions.</p>
Current status	Post-closure / Aftercare since 2009
Consequence classification ⁴⁴	High
Construction type	Hybrid of mechanical and slurry deposition. Upstream raised dams
